Vietnam War Memorial Cherry Tree Walk

Conservation Management Plan

Mittagong Rivulet, Bowral

May 2024

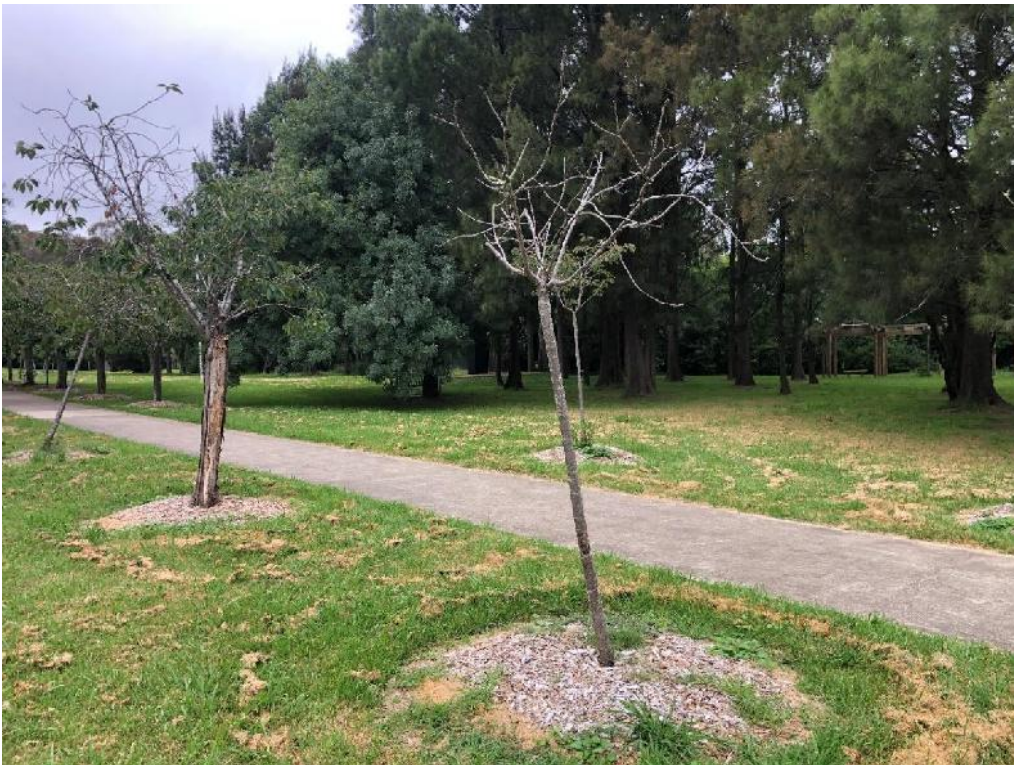
- 3.7** The three hundred and seven (307) specimens of Tai Haku Cherry Trees were assessed for this report. It has been written that there were to be one tree planted for every Australian soldier killed during the Vietnam War which, based on the Australian War Memorial totalled 523 service personnel. To date, there appears to be a deficit of two hundred and sixteen trees. Of the three hundred and seven (307) specimens, eighty four (84) were dead (27%) at the time of inspection.

Plate 3: Image showing some of the dead and dying specimens. P. Vezgoff

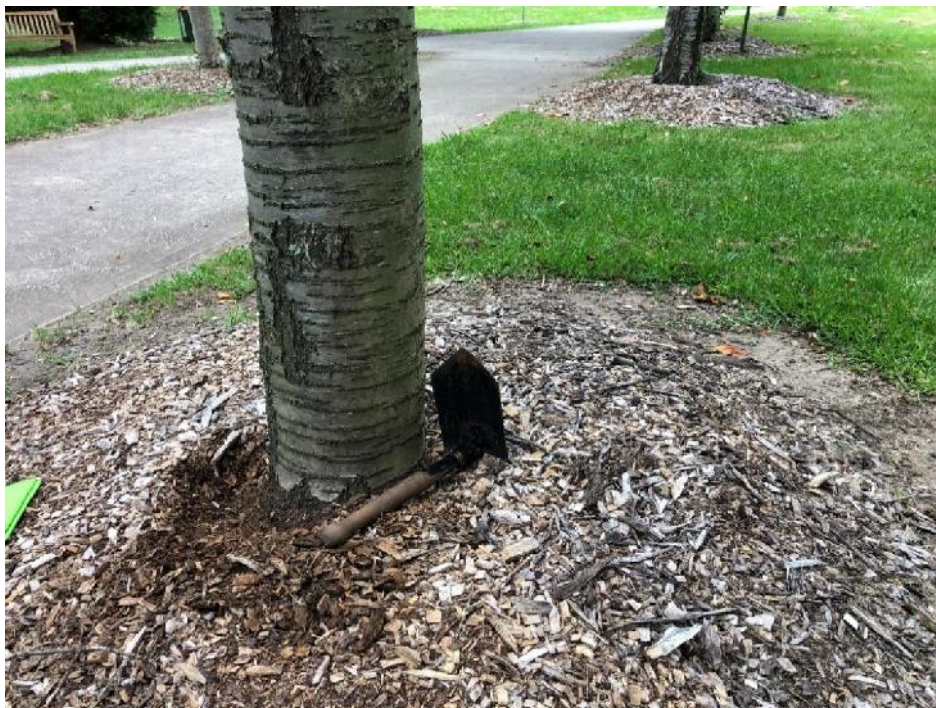
- 3.9** The study area extends from Mittagong Road along a 1.6 km concrete footpath through to Boolway Street. The path follows Mittagong Creek that lies at the base of Mount Gibraltar.
- 3.10** In total three hundred and forty four (344) trees were assessed for this report. Of these two (2) species are Sawtooth oak (*Quercus acutissima*), one (1) is English oak (*Quercus robur*) and thirty four are River oak (*Casuarina cunninghamiana*). There were three hundred and seven (307) specimens of Japanese Flowering Cherry (*Prunus serrulata* 'Tai-Haku').
- 3.11** The condition of the site trees varied greatly. Original plantings were obvious by their size as were the replacement plantings that exist along the entire study area. Most of the site trees have been mulched with a ring of mulch extending not further than 500mm for most trees. The mulch was mounded above 100mm in depth (Plate 4).

Plate 4: Image showing mulch above the basal flare. P. Vezgoff

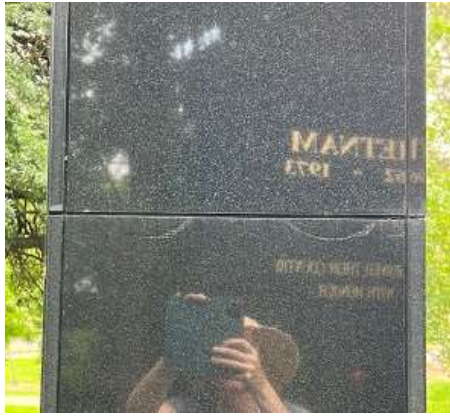
Fig 20: M3 south showing two arc shaped cracks

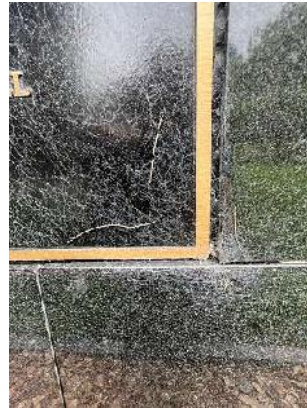
Fig 21: M3 obverse build up of cobwebs

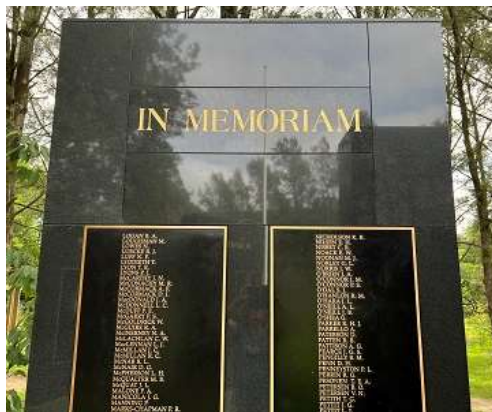
Fig 22: M4 obverse east showing four arc shaped cracks

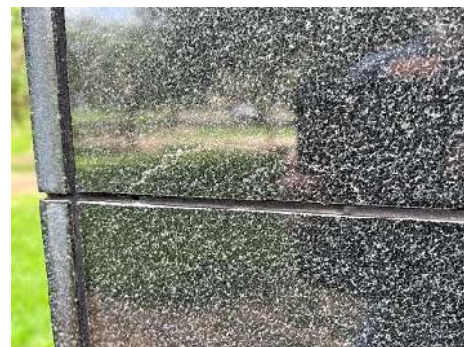
Fig 23: M4 north showing arc shaped crack and grey unpolished edge

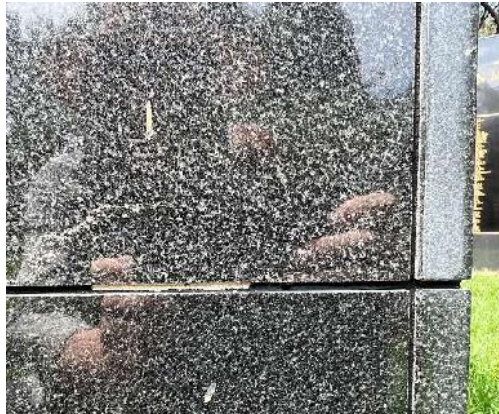
Fig 31: M7 north unpolished grey granite edge and hard white accretion below arc crack above

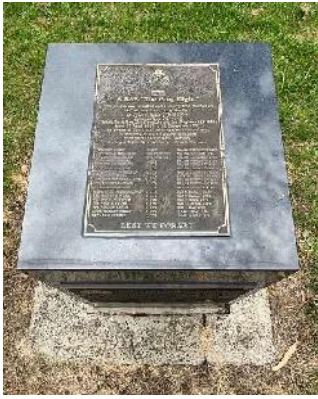
Fig 32: Oxidised brass plaque on top

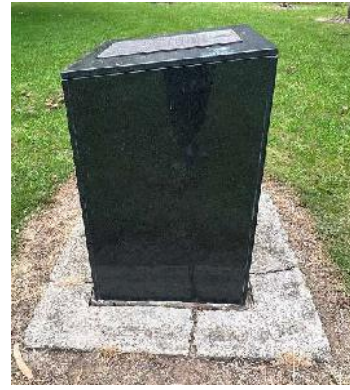
Fig 34: west side with damaged cement footings

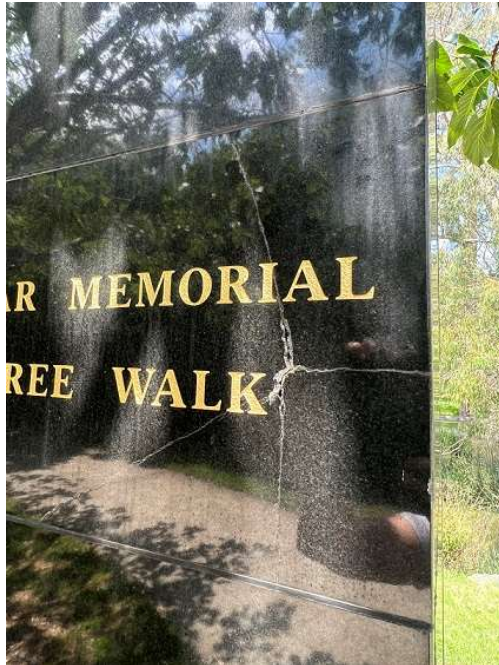
Fig 35: M9 Extensive cracking to obverse inscription panel

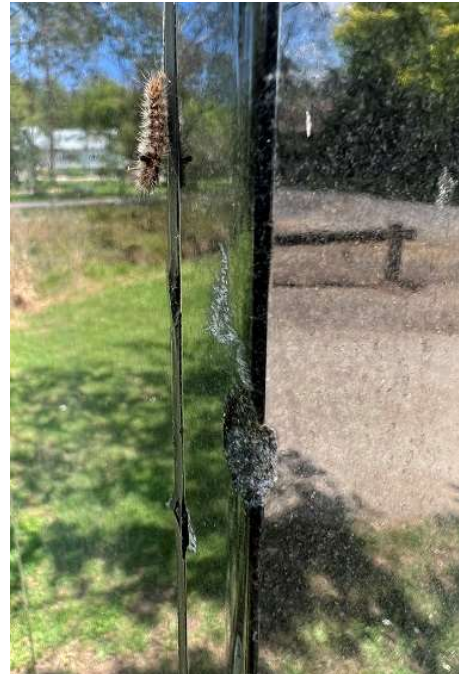
Fig 36: M9 losses to granite on SW edge below cracking on inscription panel
