Vietnam War Memorial Cherry Tree Walk

Conservation Management Plan

Mittagong Rivulet, Bowral

May 2024

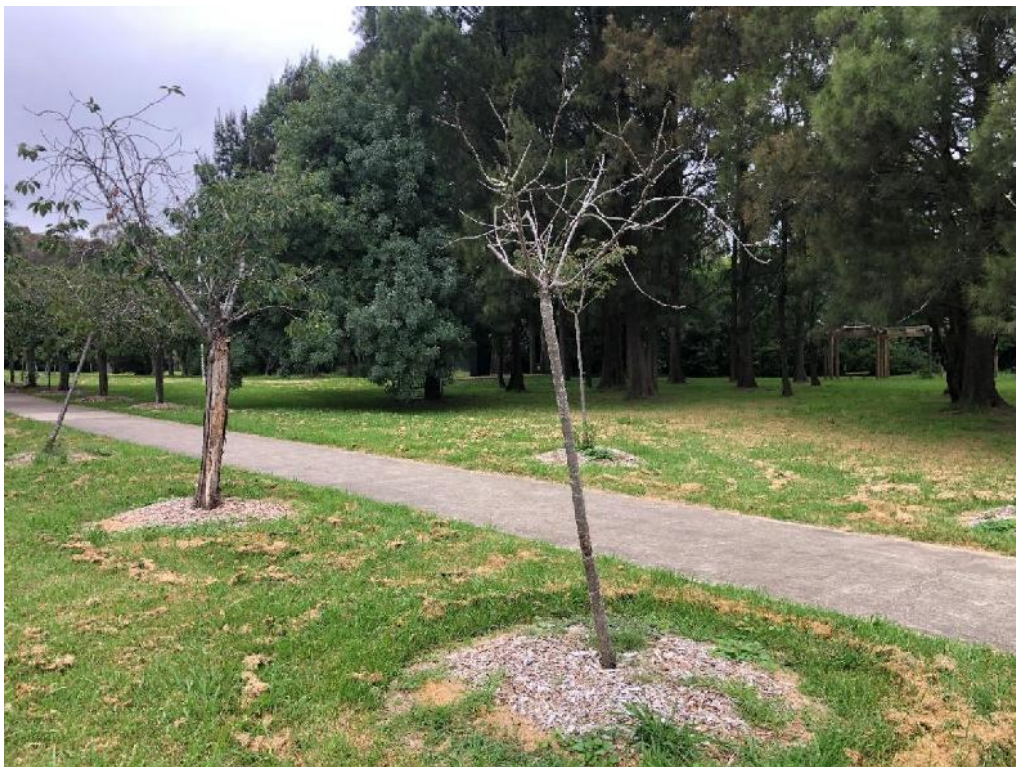
- 3.7** The three hundred and seven (307) specimens of Tai Haku Cherry Trees were assessed for this report. It has been written that there were to be one tree planted for every Australian soldier killed during the Vietnam War which, based on the Australian War Memorial totalled 523 service personnel. To date, there appears to be a deficit of two hundred and sixteen trees. Of the three hundred and seven (307) specimens, eighty four (84) were dead (27%) at the time of inspection.

Plate 3: Image showing some of the dead and dying specimens. P. Vezgoff

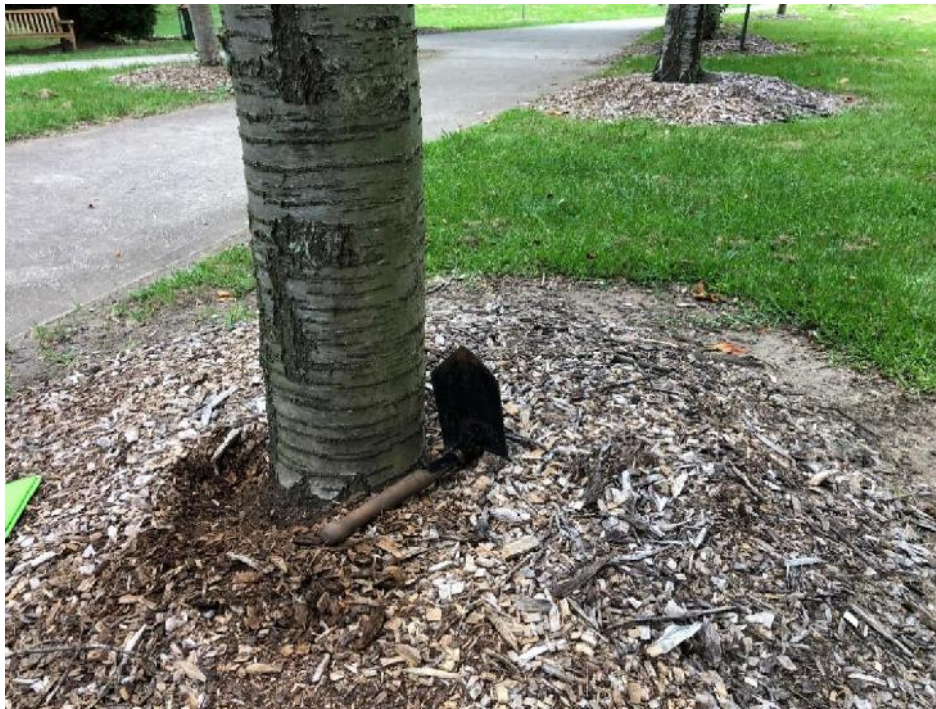
- 3.9** The study area extends from Mittagong Road along a 1.6 km concrete footpath through to Boolway Street. The path follows Mittagong Creek that lies at the base of Mount Gibraltar.
- 3.10** In total three hundred and forty four (344) trees were assessed for this report. Of these two (2) species are Sawtooth oak (*Quercus acutissima*), one (1) is English oak (*Quercus robur*) and thirty four are River oak (*Casuarina cunninghamiana*). There were three hundred and seven (307) specimens of Japanese Flowering Cherry (*Prunus serrulata* 'Tai-Haku').
- 3.11** The condition of the site trees varied greatly. Original plantings were obvious by their size as were the replacement plantings that exist along the entire study area. Most of the site trees have been mulched with a ring of mulch extending not further than 500mm for most trees. The mulch was mounded above 100mm in depth (Plate 4).

Plate 4: Image showing mulch above the basal flare. P. Vezgoff

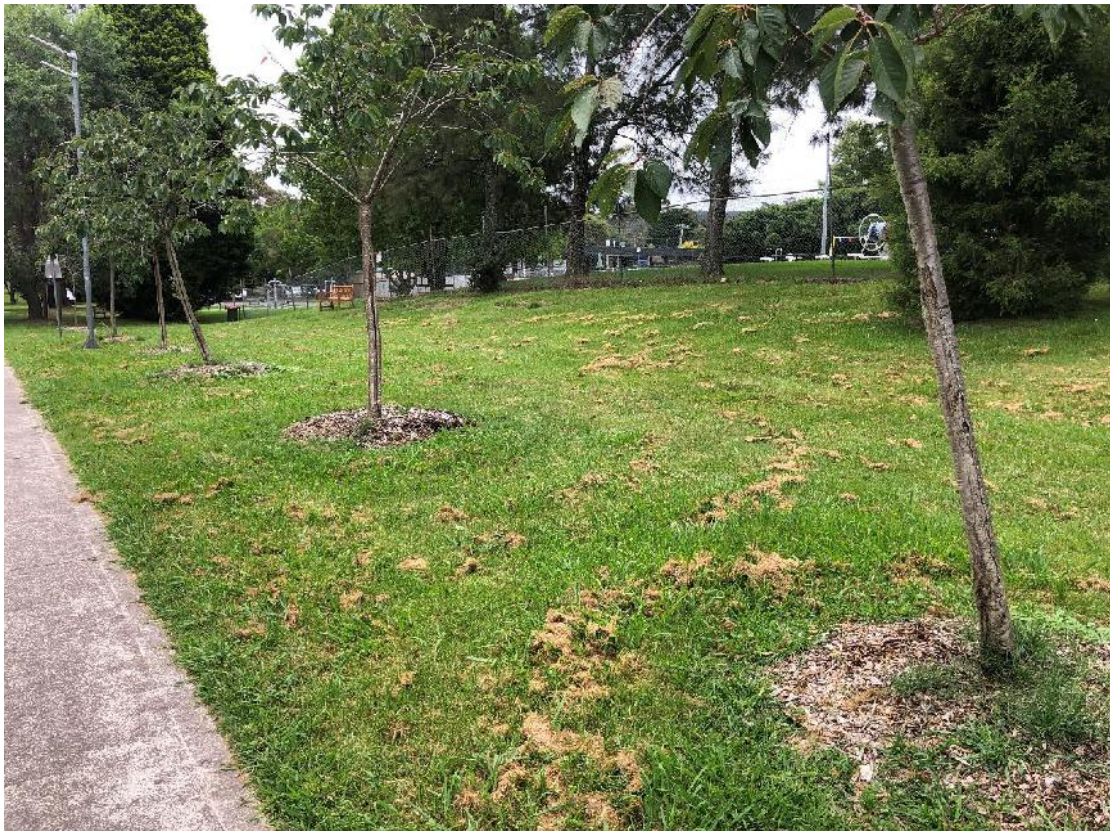
3.13 Some trees had extensive wounding to the trunks, with a degree of wound wood development. My early opinion was that possibly these wounds had been caused by flood events with debris contacting the specimens, however the damage did not correspond with the direction of water flow. Upon speaking with a local of twenty-seven (27) years, she informed me that when the walk was established vandalism occurred on several occasions. The local also stated that the stream did flood and that the water runoff from Mount Gibraltar was extensive in heavy rain events.

Plate 5: Image showing Trees 25-29 all with extensive stem wounds. P. Vezgoff

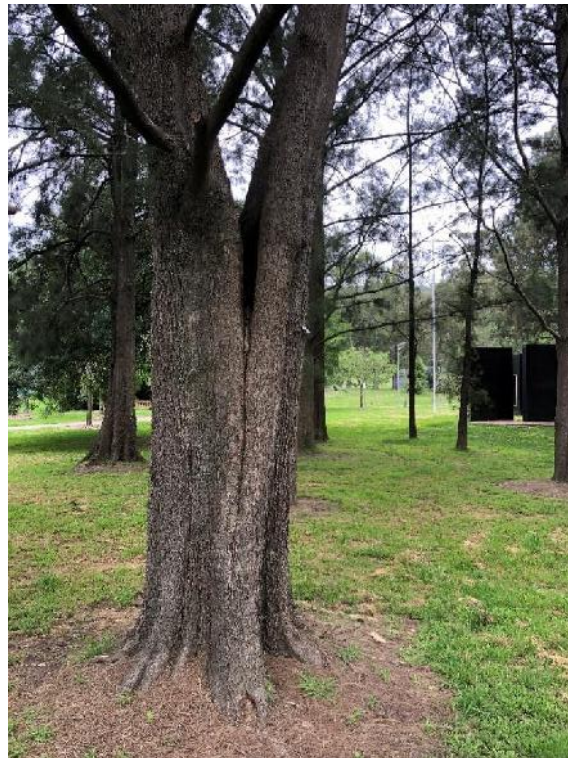
Plate 7: Image showing Tree 340 with an active crack. P. Vezgoff

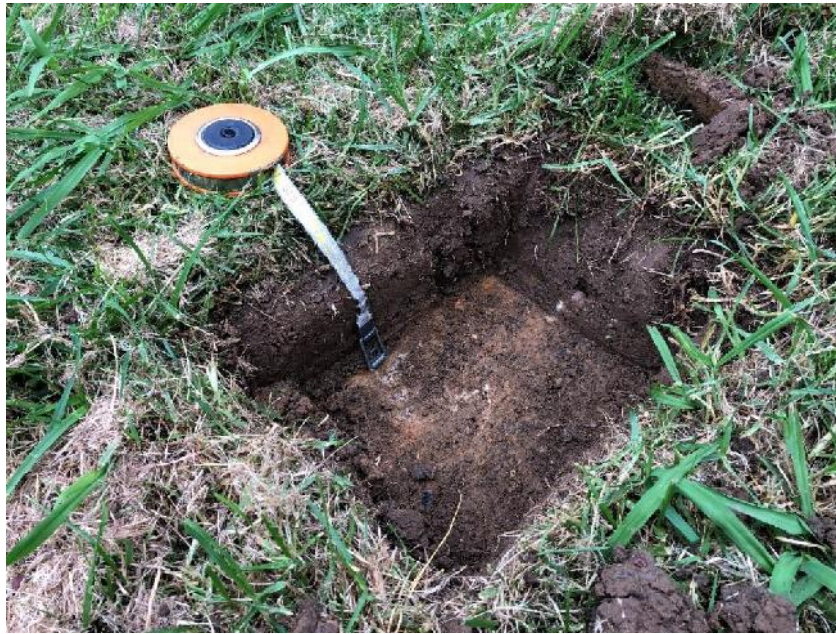
3.17 Soil compaction: A simple soil compaction test was undertaken with a metal spike around trees numbered Trees 8 to Trees 14. The soil in the entire area probed was found to be highly compacted, as evidenced by the probe only being possible to push 100mm to 150mm in depth. One hole was excavated between Trees 9 and 10. The hole was excavated to a depth of 150mm when solid compacted clay was reached (Plate 10).

Plate 10: Image showing the soil test hole. P. Vezgoff

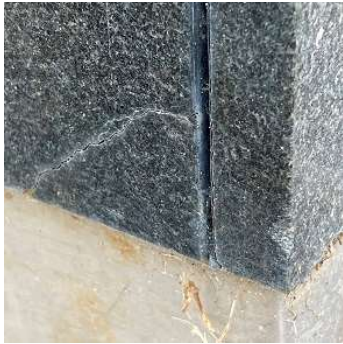
Fig 15: M2 diagonal crack and small loss lower north panel at southwest corner & tea staining on stainless steel skirt at base

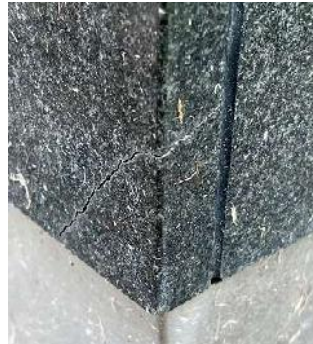
Fig 16: M2 diagonal crack lower front west panel at southwest corner

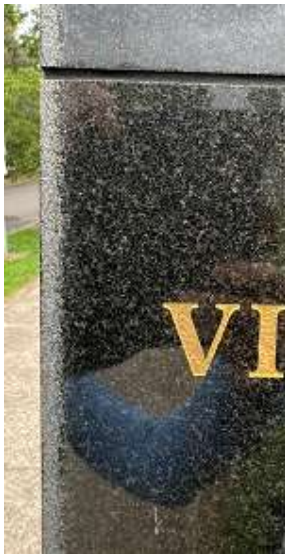
Fig 17: M2 grey area at edge loss of polished surface

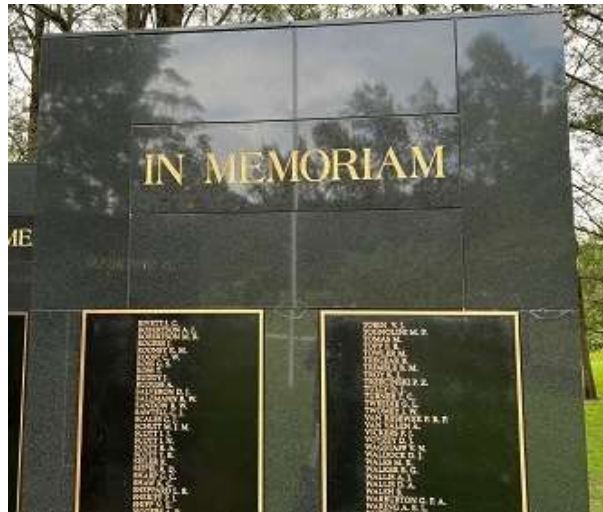
Fig 19: M3 Obverse east showing 3 arc shaped cracks and central drip mark from top join

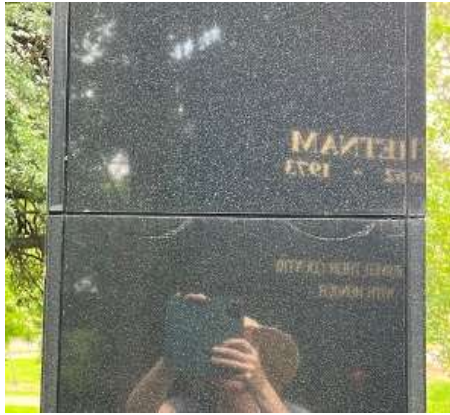
Fig 20: M3 south showing two arc shaped cracks

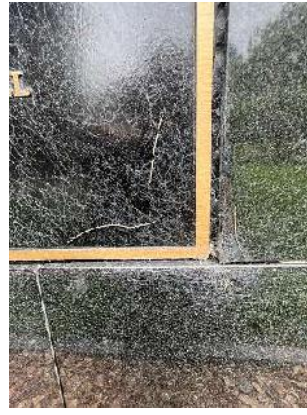
Fig 21: M3 obverse build up of cobwebs

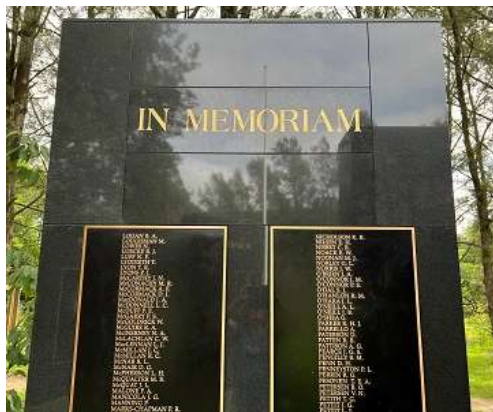
Fig 22: M4 obverse east showing four arc shaped cracks

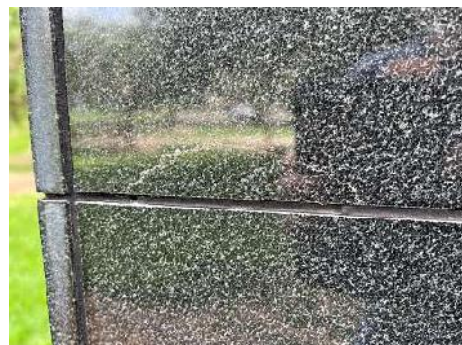
Fig 23: M4 north showing arc shaped crack and grey unpolished edge

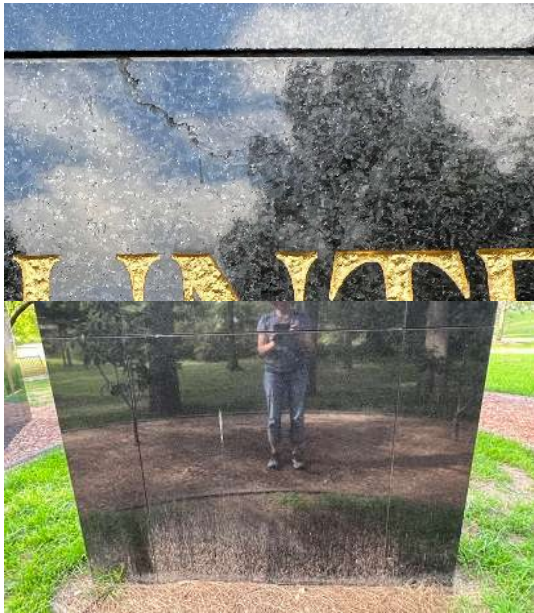
Fig 24:
M5
open
crack
above
Country

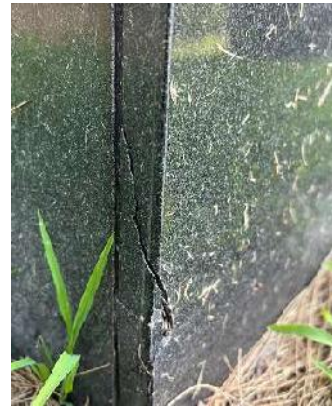
Fig 25:
M5 rear
south
dirt at
base

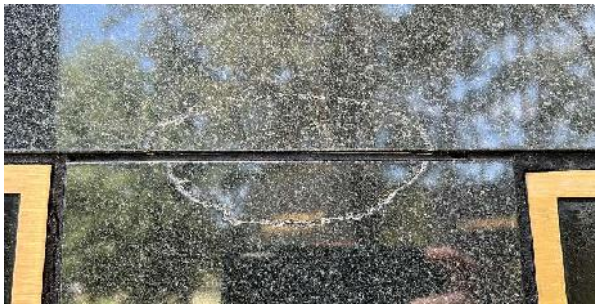
Fig 27:
M6
obverse
two
curved
cracks
between
brass
plaques

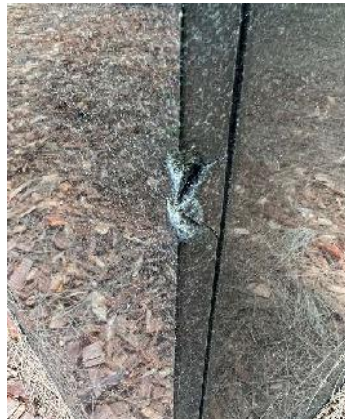
Fig 28:
M6 loss
on
southwest
edge and
crack on
west
front
facade

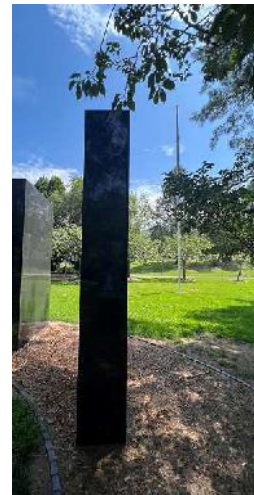
Fig 29: M6
overhanging
tree

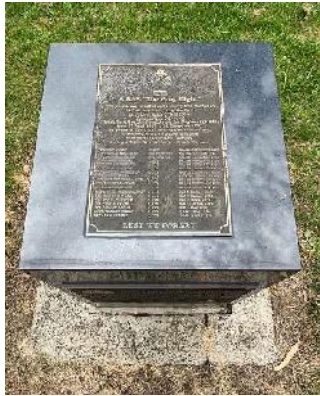
Fig 32: Oxidised brass plaque on top

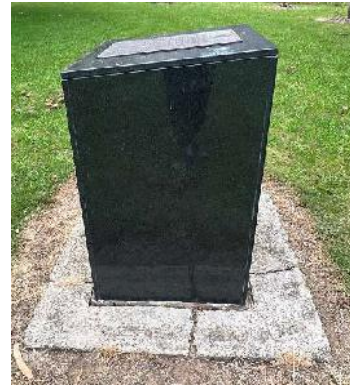
Fig 34: west side with damaged cement footings

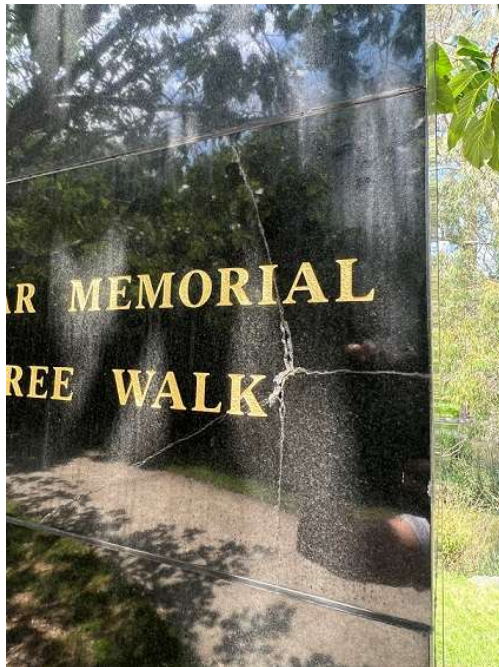
Fig 35: M9 Extensive cracking to obverse inscription panel

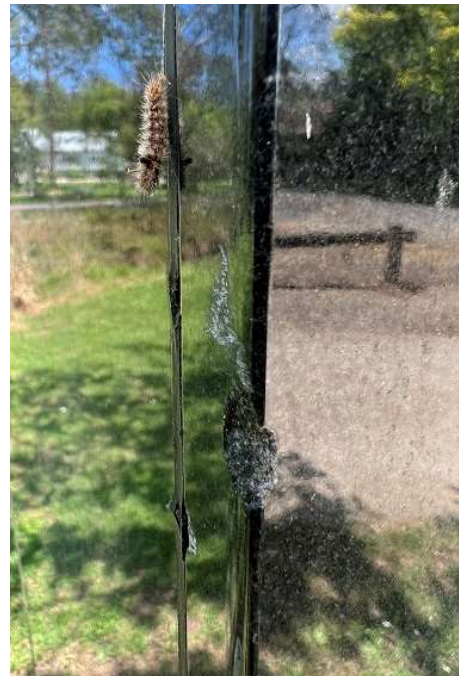
Fig 36: M9 losses to granite on SW edge below cracking on inscription panel

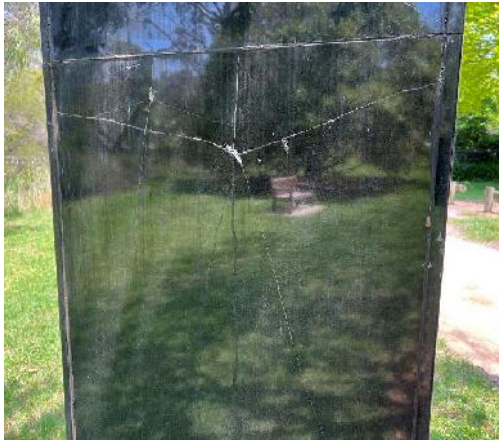
Fig 37: M9 Extensive cracking to north granite panel

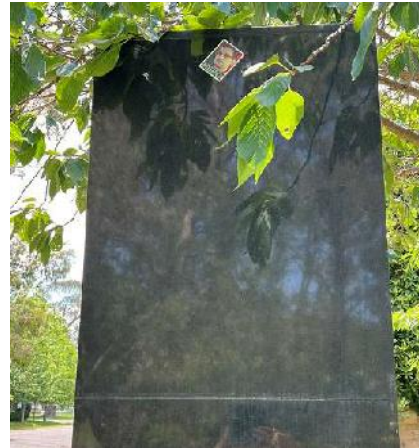
Fig 38: M9 reverse showing tree branches touching monolith and adhesive sticker
