Vietnam War Memorial Cherry Tree Walk

Conservation Management Plan

Mittagong Rivulet, Bowral

May 2024

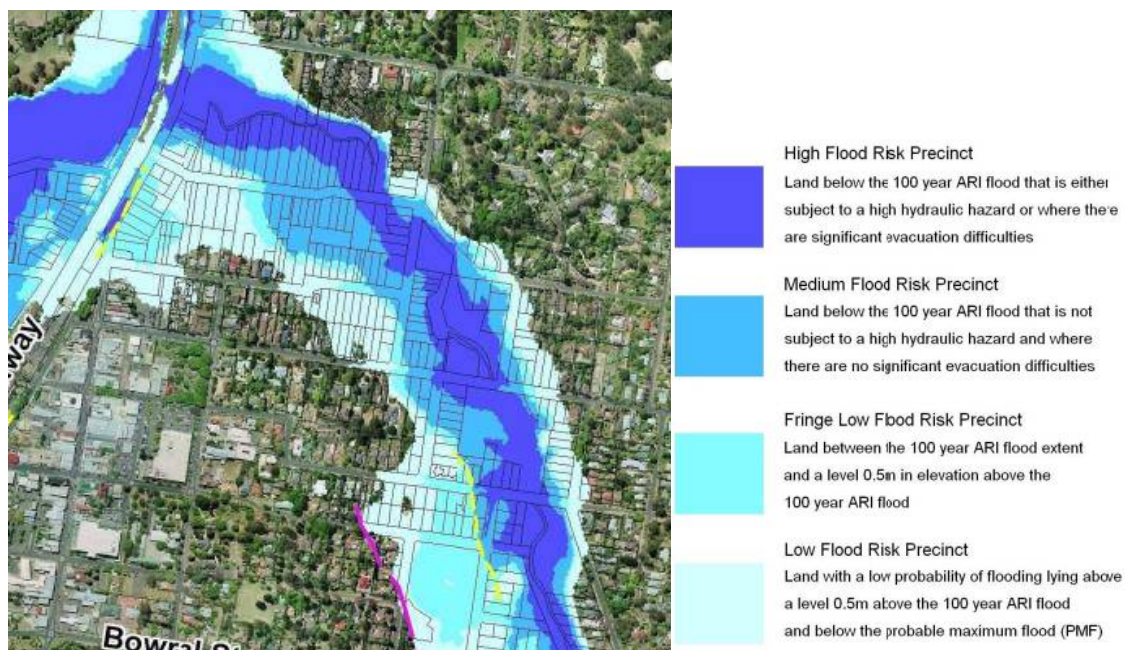
The flood map in the Brewster report shows the Vietnam War Memorial is within the high flood risk precinct. Flooding has always been a constraint for the memorial. The original designers were well aware that flood risk was a factor.

Figure 53. Flood risk areas associated with Mittagong Creek. (Bewsher Consulting Pty Ltd, 2009)

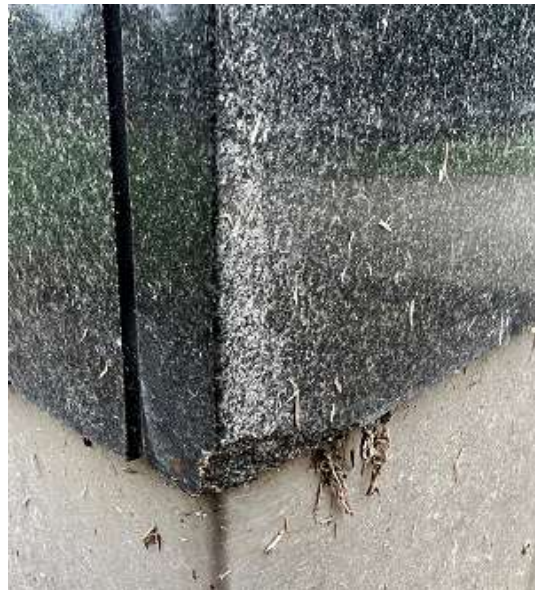
Chips and losses from the granite are evident in the following areas: i) obverse west facade lower panel lower north corner small loss, ii) rear east facade abrasion on lower panel northeast corner, and iii) rear east facade medium loss on lower panel southeast corner (Fig 18).

Fig 18: M2 loss at lower southeast corner

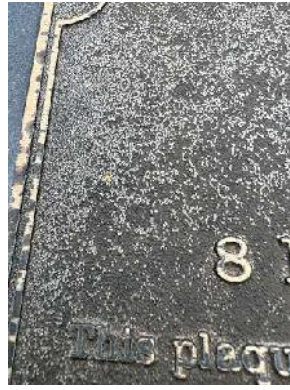
Fig 33: Detail of top oxidised brass plaque
