Vietnam War Memorial Cherry Tree Walk

Conservation Management Plan

Mittagong Rivulet, Bowral

May 2024

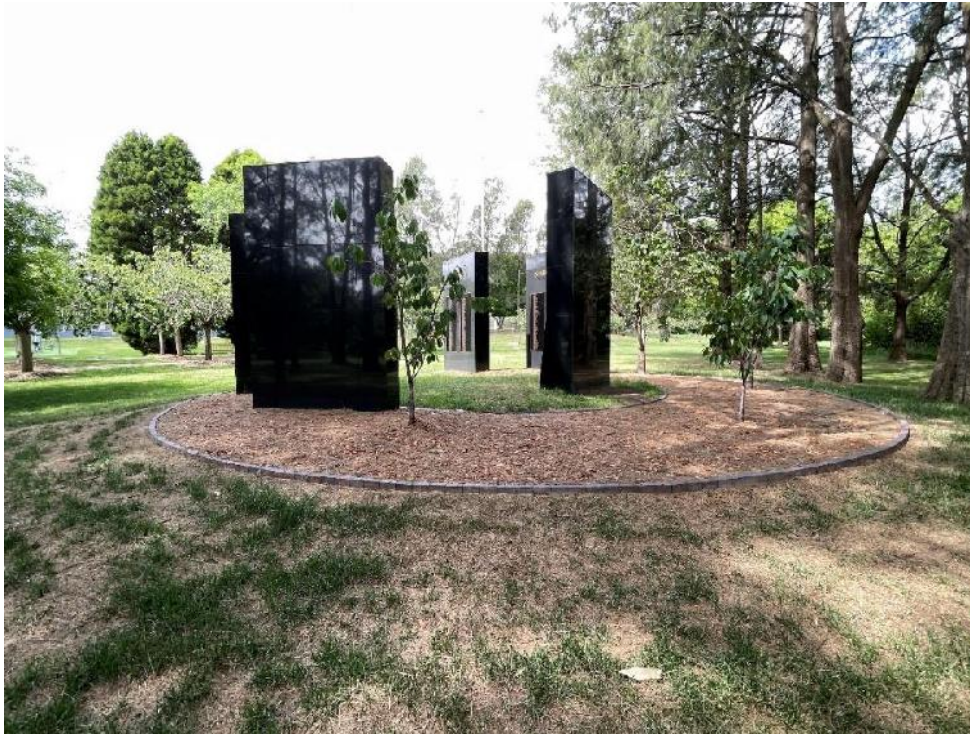
Figure 39. The monument after modification works.

In 2021 members of the Southern Highlands Vietnam Veterans Association met with Council staff to discuss their concerns regarding the monument. They were concerned that garden beds were overgrown, and three of the four Cherry Trees had died and the evidence of flooding could still be seen at the monument. They put forward proposals to address these issues and applied to Department of Veterans Affairs (DVA) for funding. A grant of \$61,000 was received from the DVA in February 2022 to prepare a CMP and for minor landscaping works prior to the commemoration of the 50th Anniversary of the end of the Vietnam War.

- 1. Retain the one surviving cherry tree on the memorial (monument) site.*
- 2. Provide three new cherry trees to replace the three failed (dead) cherry trees.*
- 3. Remove existing vegetation and soil within the inner and outer circles and replace with new soil.*
- 4. Install sub-surface drainage within the inner and outer circles on the southern side of the monument area.*
- 5. Construct a concealed concrete cut-off wall of variable height to a maximum of 400 mm on the alignment of the outer circle's southern quadrant to protect against flooding.*
- 6. Repairs to the inner and outer circle edging by reusing existing pavers laid vertically (as originally placed), including making the inner and outer edges align horizontally and vertically as concentric circles.*

7. Provision of new mulch within the inner and outer circles.
8. Uplifting of selected casuarina trees to allow in more light.
9. Provision of new park seat.
10. Maintenance work, including repainting, of the nearby Peace Pavilion.

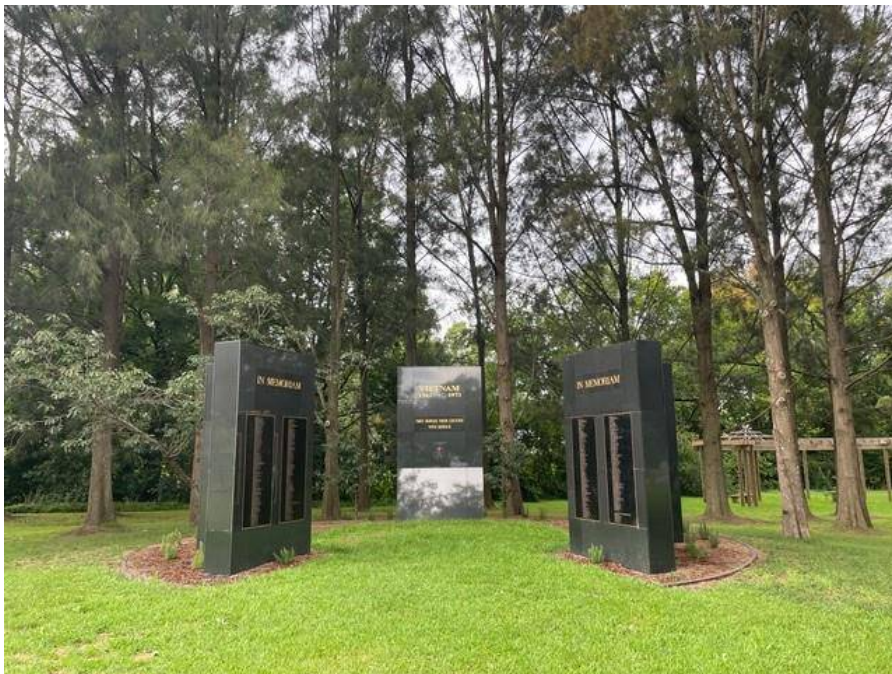
Figure 43. The monument as existing 20 March 2024. (Tooth G. , 2024)

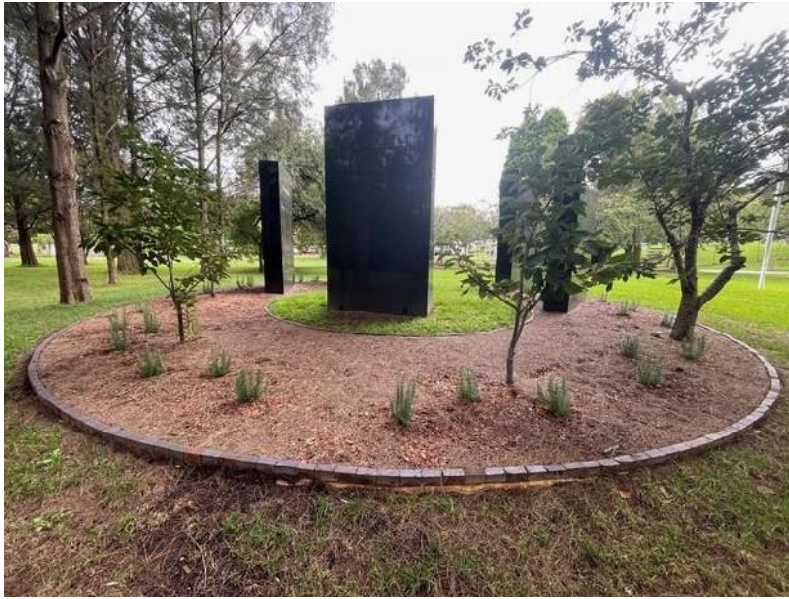
Figure 44. The garden bed around the monument as existing 20 March 2024 (Tooth G. , 2024)

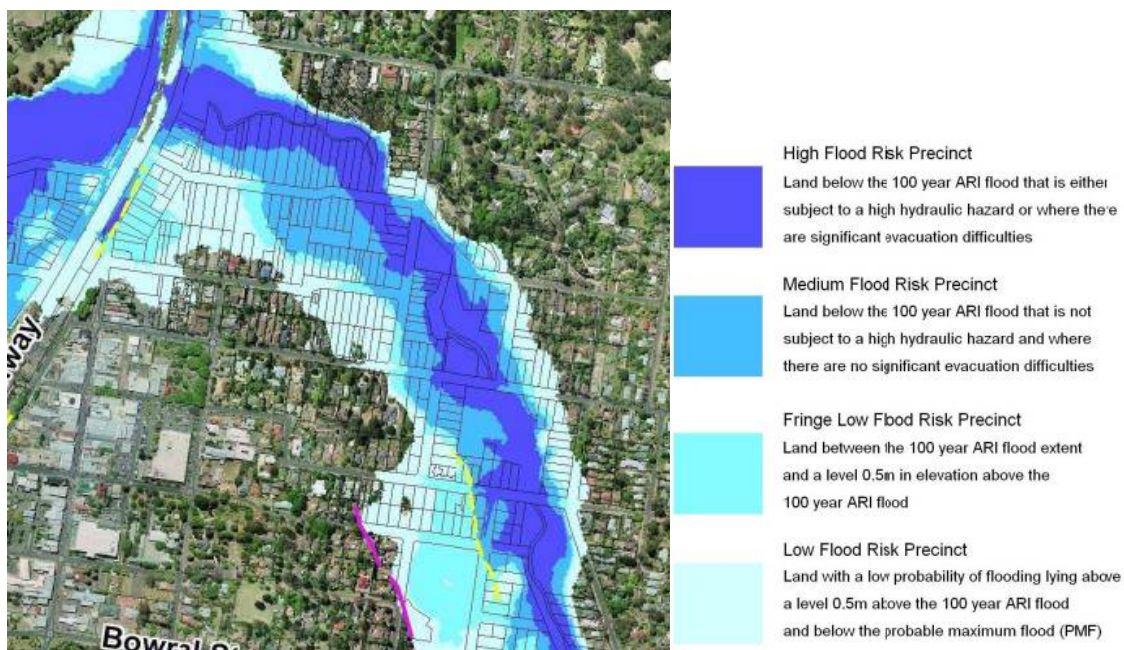
The flood map in the Brewster report shows the Vietnam War Memorial is within the high flood risk precinct. Flooding has always been a constraint for the memorial. The original designers were well aware that flood risk was a factor.

Figure 53. Flood risk areas associated with Mittagong Creek. (Bewsher Consulting Pty Ltd, 2009)

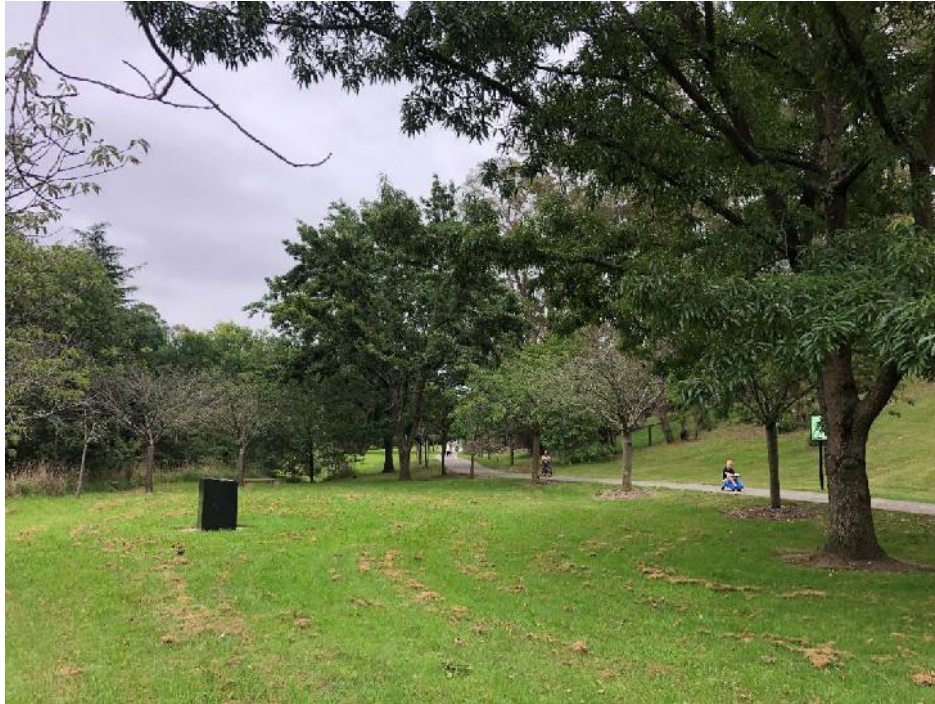
3.16 8 RAR Memorial: The 8 Royal Australia Regiment Memorial area is surrounded by Trees numbered as Trees 188 to Trees 199. This memorial area contains a small stone monument surround by lawn area. Several of the Cherry trees have died in this area. Two (2) mature specimens of Sawtooth oak (*Quercus acutissima*) are present, and both are in good health and condition.

Plate 8: Image showing the 8 RAR Memorial. The Sawtooth oak (*Quercus acutissima*) to the right and centre of the image. P. Vezgoff

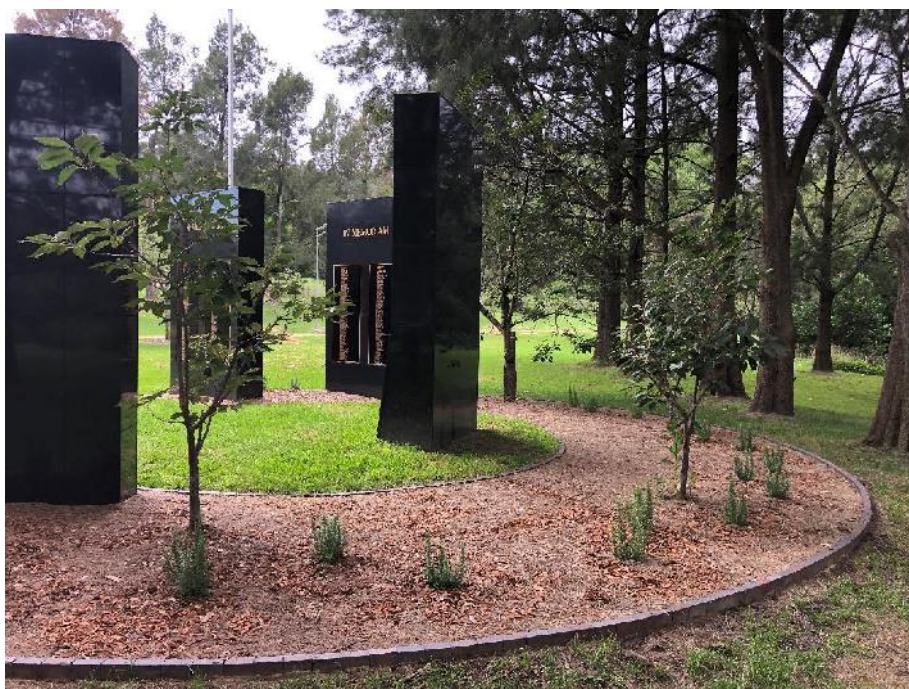
3.15 A small garden area next to the granite towers contains four (4) small Cherry tree specimens. One (1) tree is older than the other three (3) trees. The other three (3) trees appear to have been planted in the last 2-3 years. All four (4) are in good health and condition (Plate 9). They have underplanted with Rosemary (*Salvia Rosmarinus*) bushes, which is often associated with ANZAC Day.

Plate 9: Young specimens near the granite towers. P. Vezgoff

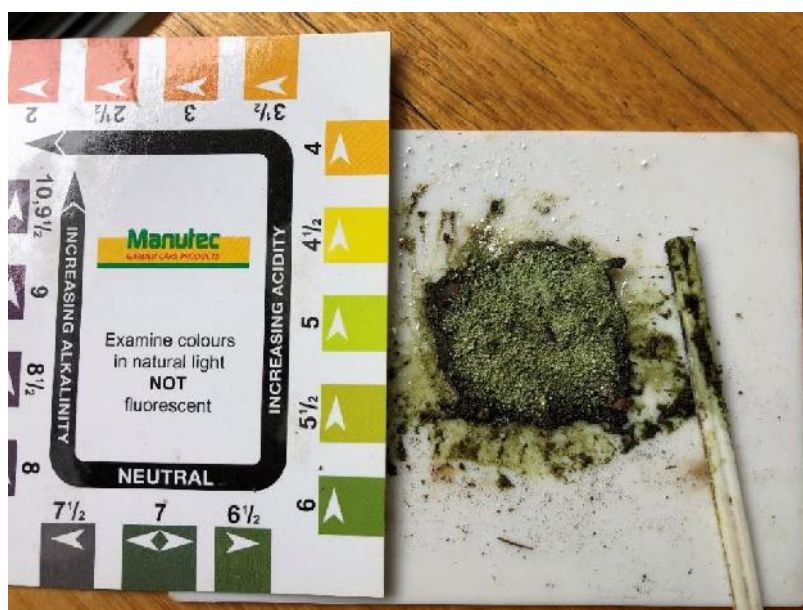
3.18 Soil pH: Three soil pH tests were undertaken from the base of Trees 299, 208 and 167. The tests revealed the pH to generally be between 5 and 6.5, that being a slightly acid soil.

Plate 11: Image showing one of the soil pH test results. P. Vezgoff

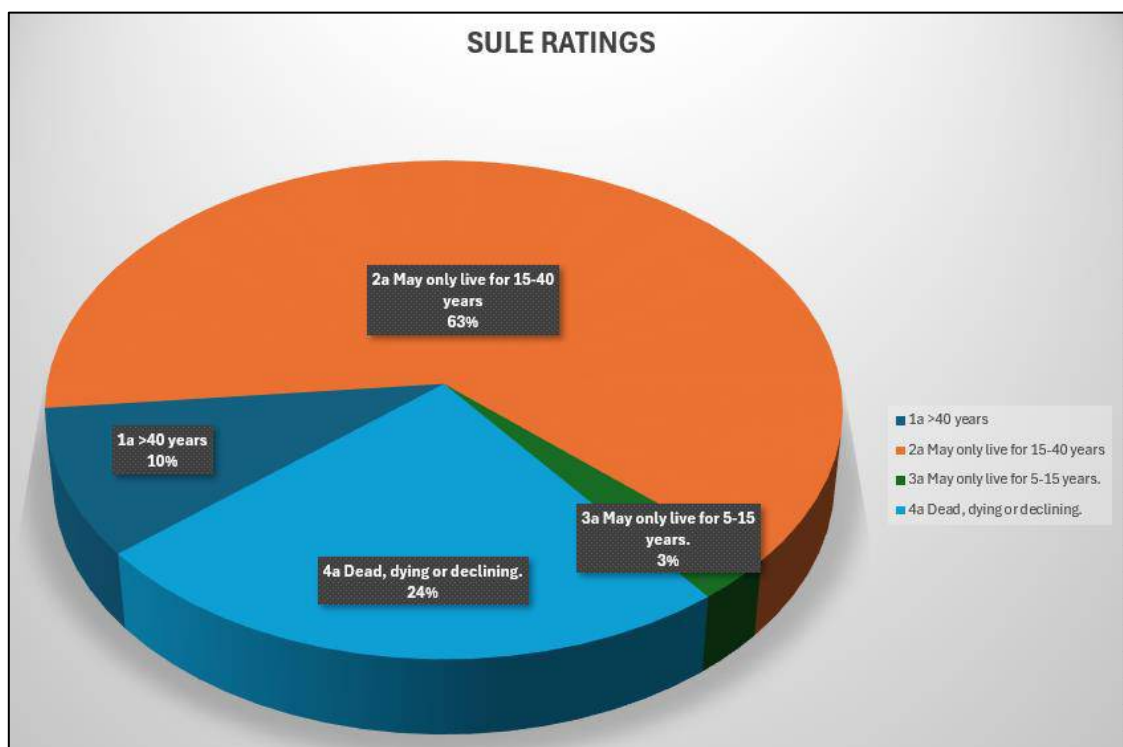
3.23 Safe Useful Life Expectancy (SULE) is a method of evaluating individual trees. The evaluation is a subjective assessment, not an absolute judgement, because the nature of trees and opinions on trees can vary greatly. SULE assessments are made only by those who are experienced and knowledgeable in tree management. SULE is generally accepted and used world-wide as a method of evaluating trees. Each category has a number of sub-categories. These sub-categories should always be recorded to help future users of the information appreciate the reason for each allocation decision. It is normal to have instances where trees will not fit neatly into a single SULE category. The assessment of the site trees can be seen in Graphs 1 and 2. Based on the site age and current condition of the site trees I have not rated any Cherry tree greater than 2a (15-40 years). However, it should be noted that the *Casuarina* species do skew the results due to their 1a rating. As such, Graph 1 shows the SULE ratings including the *Casuarina* species and Graph 2 without.

Graph 1: SULE ratings for the site including the *Casuarina* species.

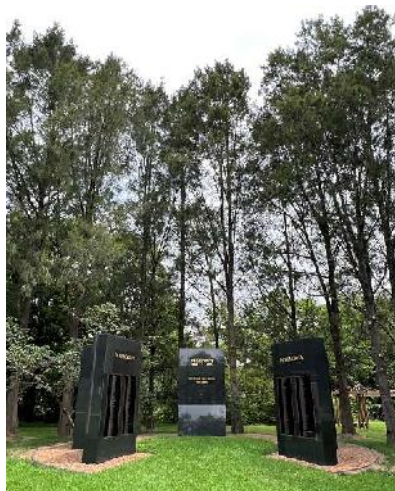
A site visit on 12-13 December 2024 to inspect the Memorial was carried out by Anne Cummins of SAC. The Memorial was at that time in fair condition with various cracks evident on the granite panels on all monoliths apart from one (M1). The most prevalent crack types were an arc shaped crack which arched from join to join at the horizontal edge of the panels and diagonal cracks across the corners. Possible vandalism was only noted on one of the monoliths M9 which is the most remotely located.

Fig 1: M3-M7 the main five monoliths in open circle formation

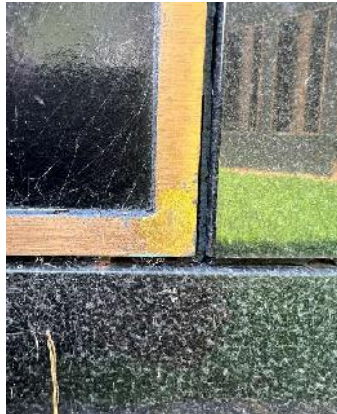
Gold paint has been applied to the lower corners of the left honour roll plaque (Fig 30) and sections of the right brass edge, presumably in attempt to cover discolouration of the polished brass edge.

Fig 30: M7 obverse west gold paint in corner of left plaque

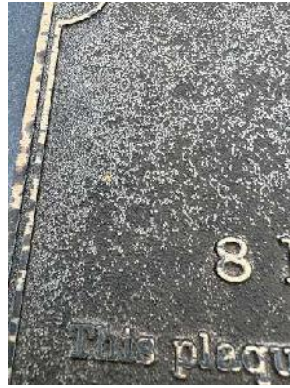
Fig 33: Detail of top oxidised brass plaque
